CRYSTAL LAKE DAM

JEFFERSON COUNTY, MISSOURI

MO 30462

PHASE 1 INSPECTION REPORT NATIONAL DAM SAFETY PROGRAM

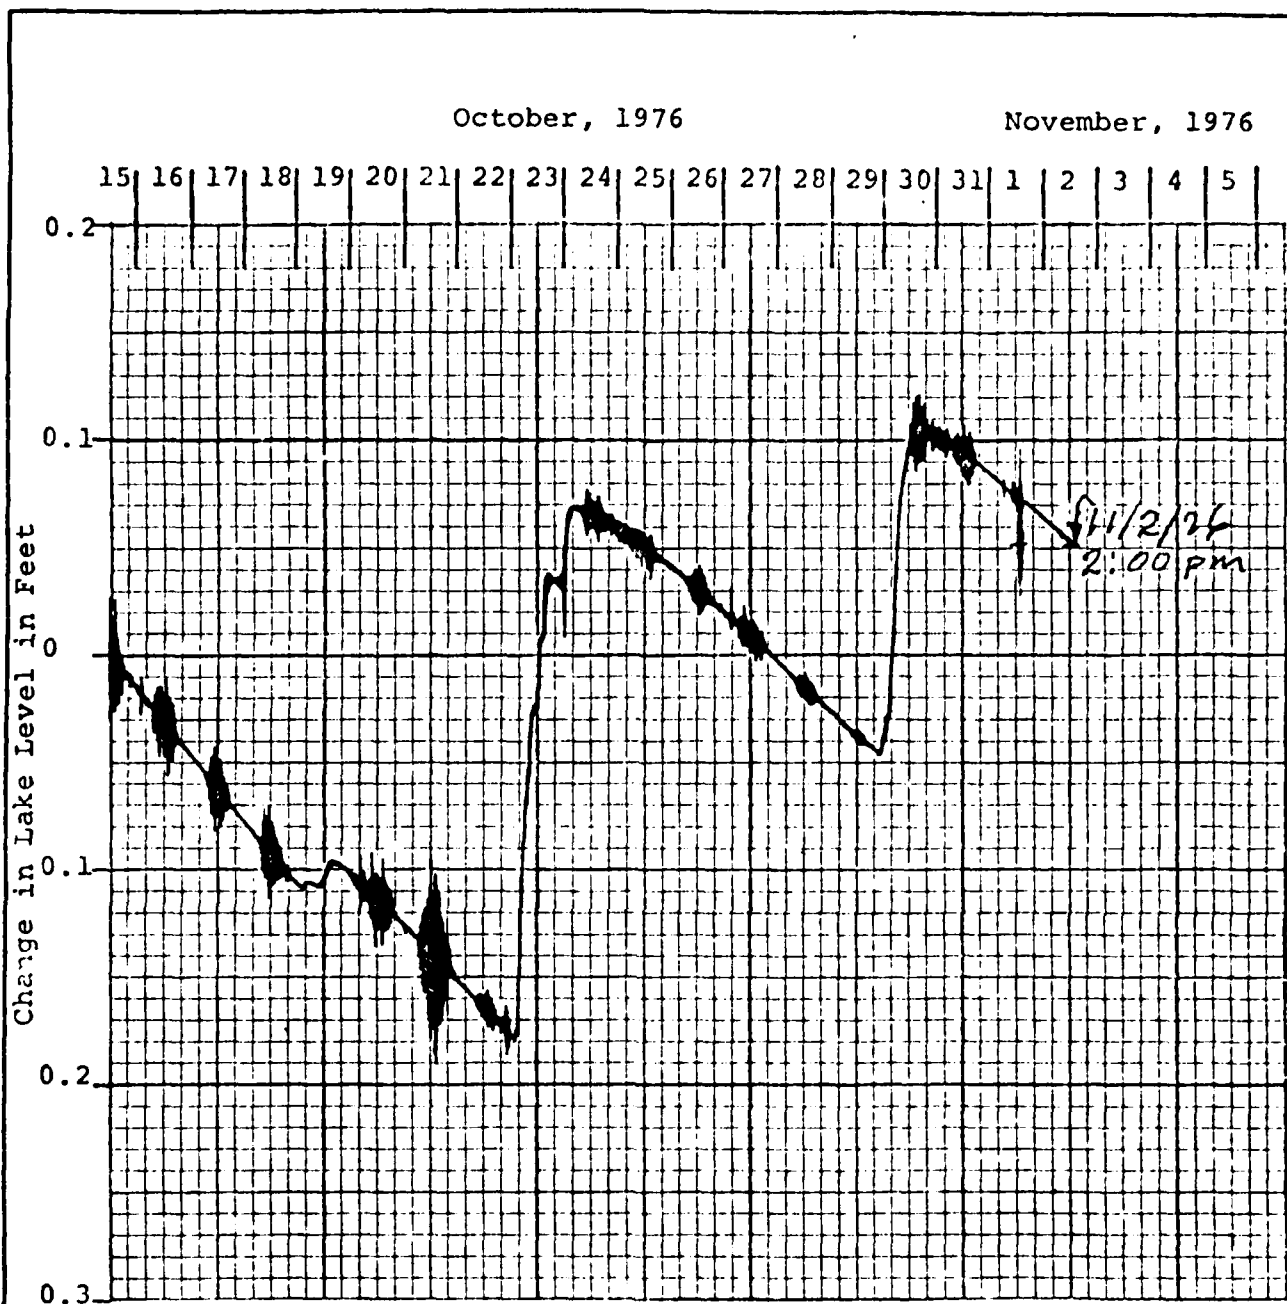
Figure 2

A water level recorder was installed on the lake on October 15 and removed on November 2, 1976. The recorder plot is shown on Figure 2. On October 19 there was 0.5 inches of rain and there was 2.1 inches of rain on October 23 and 24. Also 1 inch of rain fell on October 29 and 30. As is evident from the plot, the lake level dropped except during periods of rain. The initial rate of drop (before 10/19/76) was 0.37 inches per day or about 14.3 gpm. The rain on October 19 resulted in a slight rise in the lake level. The immediate runoff was only about 4.2 percent of the rainfall on the watershed. From October 19 to 23 the lake level lowered at a rate of about 0.30 inches per day indicating some continued runoff. On October 23 and 24, about 2.1 inches of rain occurred which resulted in a 3.4 inch rise in the lake. The immediate runoff was about 8.4 percent of the total rainfall. The rate of decline in the lake level afterward was 0.27 inches per day. On October 29 and 30 an additional one inch of rain occurred, which raised the lake level 2.1 inches and an indicated runoff of 11.0 percent of the total rainfall. The subsequent lowering of the lake was at about 0.26 inches per day.

As it was relatively dry prior to the time the recorder was installed, the initial rate of fall in the lake level was probably not affected to a great extent by recharge. As a result, it appears that the rate of leakage from the lake is about 14.5 gpm for the lake level at the time. The rate of leakage would increase some if the lake were full. The amount of increase is not known, but it probably would not be more than about 25 percent. At a leakage rate of 14.5 gpm the total loss would be about 7,500,000 gallons as shown on Figure 3.

LAKE LEVEL MEASUREMENTS
